## Remarks on Mariana and Brumadinho tailings dams' disasters (Minas Gerais, Brazil)

**D.V. Znamensky**

**Abstract.** Inadequate layout and drainages galleries failures resulted in very poor tailings drainage in Mariana case. Seismic chocs of moderate magnitude occurred shortly before the reservoir rupture. Failure occurred at noon hours what allowed reasonable large escape of Bento Rodrigues village inhabitants and relatively small number of victims. At Brumadinho site a delayed and interrupted fill drainage process created a critical saturation state and sudden rupture by retaining water of the Feijao creek. A dangerously close location of the office and personal facilities provoked a large number of fatalities in this case. Heightening of the fill was interrupted at close to 80 meters.

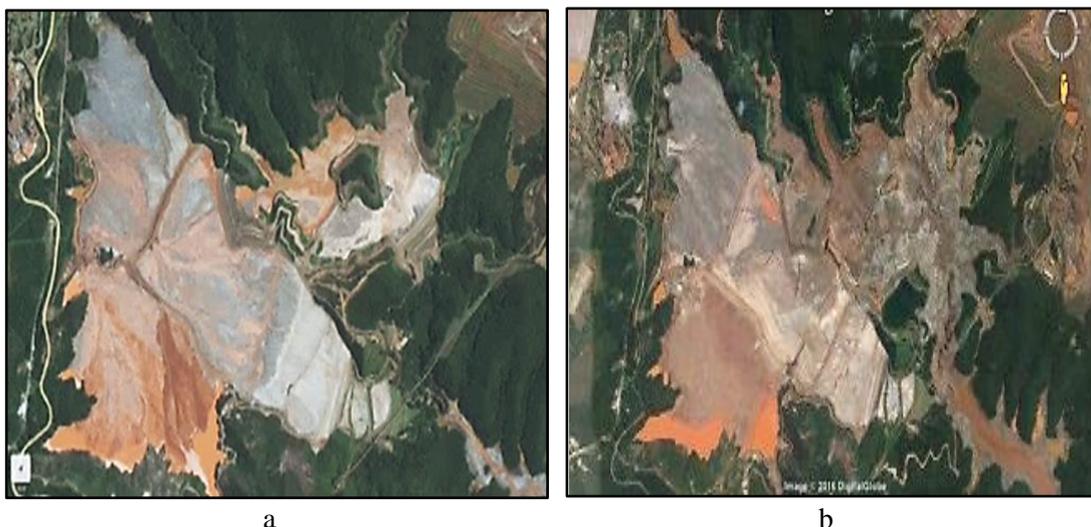
Its frustrated operation is the first cause of the other failures of this project, as it compromised the control and management of both the liquid phase of the mud and the natural flow of the basin streams.

Thus, due to lack of drainage, the deepest part of the reservoir was initially saturated.

The stockpile rupture occurred in two stages: at the left bank and at the abutment near Vale's exploration pit, and at the dam where the initial rupture gradually spread throughout the supersaturated reservoir.

Fig. 1. Fundão Dam and Reservoir; (a) during construction and before rupture, and (b) after rupture and upon emptying of the reservoir

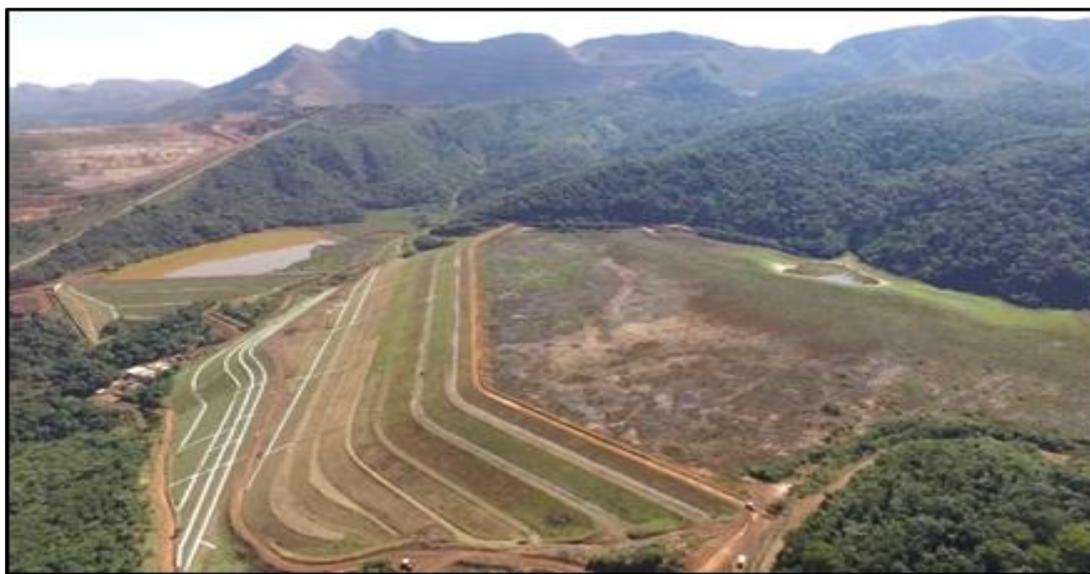
Therefore, the rupture occurred due to the supersaturation ( $G_{ssat} > 1$ ) of the tailings due to the lack of adequate drainage of the stocked mass, which apparently failed to be done.

Fig. 2. Brumadinho Dam and Reservoir before rupture with the undrained water puddles on its surface
