DEBRIS FLOWS: Disasters, Risk, Forecast, Protection

Tbilisi, Georgia, 1-5 October 2018

The mud/debris flow of the Stava (Italy) tailings dams break

R. Genevois¹, P.R. Tecca²

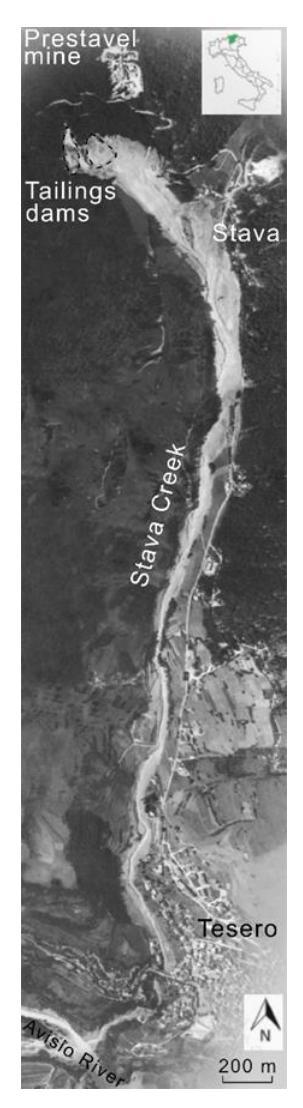
This paper presents a well-documented case of the failure of two tailings dams of a fluorite mine, occurred in 1985, at Stava (North-Eastern Italy) (Fig. 1). The failure produced a catastrophic flow slide and consequent mud flow, which wiped out or buried two villages and claimed 268 lives, completely destroying 3 hotels, 53 homes, and six industrial buildings; 8 bridges were demolished and 9 buildings were seriously damaged.

Fig. 1. Aerial view of the area impacted by the mudflow and location of the tailing dams (Aerial photo: Permit of the general staff of the Italian Air Force No. 01-120 and No. 01-121 of March 22, 1995)

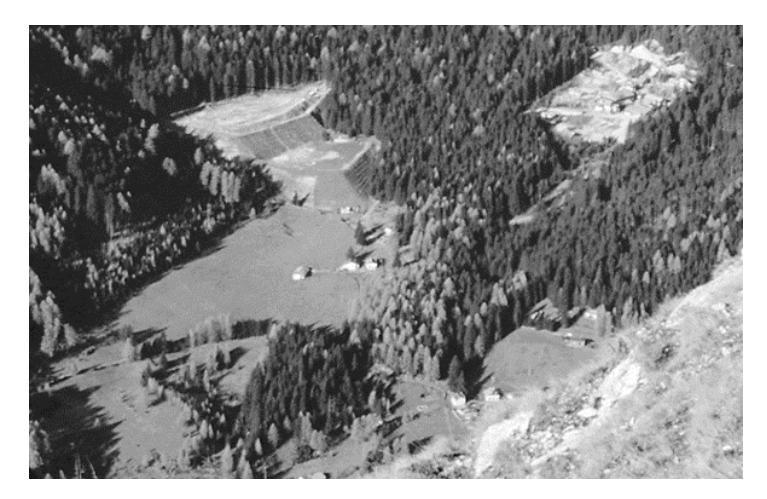
For this purpose, two basins were constructed on a small tributary of the Stava Creek, at an elevation ranging from 1330 to 1380 m a.s.l., on a slope between 12° and 16°. The lower basin was located about 120 m above the Stava valley floor, in a distance of 800 m to the small village of Stava. Fig. 2 shows the aerial view of the two basins photographed in September 1982.

Fig. 2. Aerial view of the two tailings dams in 1980 [Archivio multimediale Fondazione Stava 1985 Onlus. http://multimedia.stava1985.it/search.html]

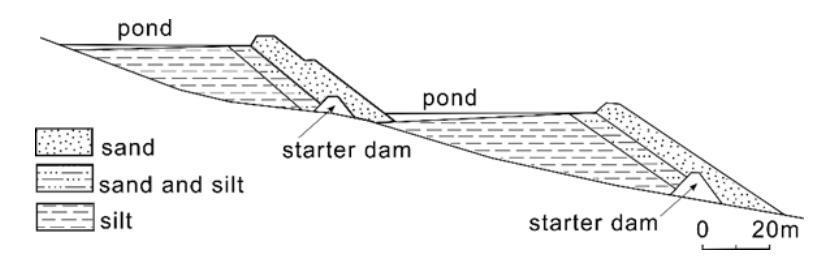
The impoundments were founded on fluvio-glacial deposits covering a marly-arenaceous formation. The local geological features have an important significance because of the different permeability of the formations and the consequent possible existence of confined aquifers. The lower dam was raised on natural ground using the "upstream method": centreline of the embankment moved upstream, in relation to the starter dam, so that the upstream wall was built on the tailings beach. The upper dam was initially raised using the "centreline method" (embankment crest shifted upwards in the same position, in relation to the starter dam), so that, as the dam grew higher, its sandy front rested partly on the lower pond silty sediments (Fig. 3); from 1975 the upper dam was raised using the "upstream method".

Fig. 3. Schematic cross section of the tailings dams

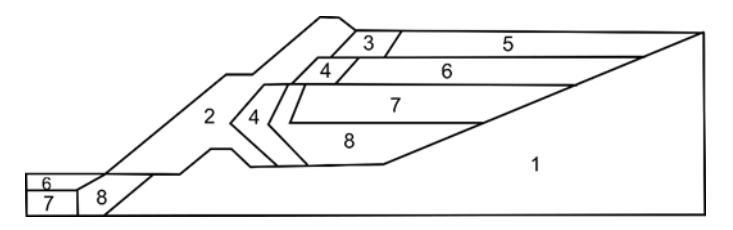
Considering a range of possible piezometric surfaces within the sandy shell, *Genevois* and *Tecca* [1993] carried out stability analyses using a two-dimensional non-linear finite difference code [*FLAC*, *Itasca Consulting Group 1992*]; the Drucker-Prager plasticity model was implemented on a simplified geometry of the tailings dam (Fig. 4), considering a range of possible piezometric surfaces within the outer sandy shell. The input geotechnical parameters are showed in Table 2.

Fig 4. Geotechnical model of the 1985 Upper dam. 1- natural soil; 2- sands; 3- very soft alternating soils; 4- soft to medium alternating soils; 5- unconsolidated slimes; 6- very soft slimes; 7- soft slimes; 8- medium consolidated slimes

The results of the analyses showed that the stability of the upper dam is mainly influenced by the dam height and by the position of the phreatic surface within the sandy shall and.

The safety factor displayed an initial increase due to the progressive consolidation of the slimes and a significant decrease after 1982, when the instability condition was reached for high piezometric levels.

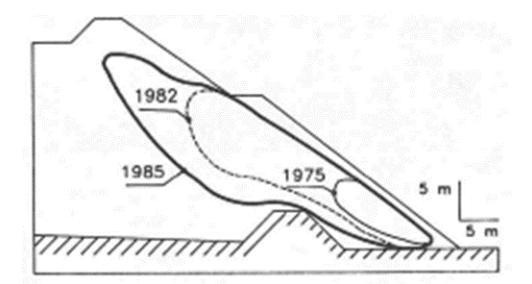
The influence of the height increase of the upper dam was evaluated implementing the *Lade* [1992] procedure, identifying a region of potential instability. A local zone of instability already existed in 1975, and it extended more and more upwards and inwards as the dam height increased, eventually engaging the silty sands alternating layers and part of the silty tailings (Fig. 5).

Fig. 5. Progressive extension of the instability zone during the upper dam building

The upper dam, however, was stable as long as drained conditions were secured: any pore pressure build up would have resulted into the enlargement of the unstable region, the engagement of progressively larger volumes of unstable tailings and finally into the dams failure by static liquefaction.

As regards the initial failure of the upper dam, the causes should be referred in general to the poor engineering of the construction and, in particular, to the raising of the upper dam with a steep downwards slope. As a conclusion, the dam was only marginal stable and it would have in any case collapsed.

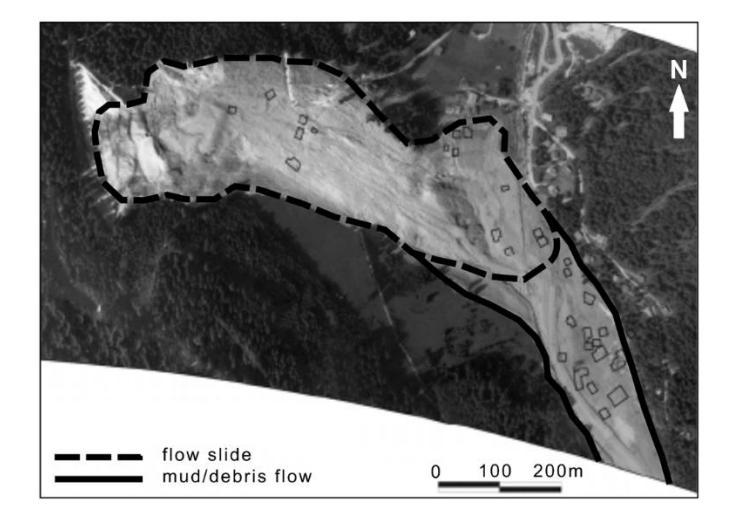
The Stava event has been subdivided into two different processes (Fig. 6): a flow slide from the tailing dams to the Stava village, where significant depositional processes took place, and a mud/debris flow along the Stava valley, where only erosional phenomena occasionally occurred [*Berti et al. 1997*]. The distinction in two processes is also confirmed by the interpretation of the seismogram recorded at Cavalese, 4.1 km from the Prestavel basins.

Fig. 6. The flow slide area with remnants of the dams and the upper part of the mud/debris flow a few hours after the disaster [photo Aeron. Mil., conc. S.M.A. no. 623, 19 July 1985].

Based on the Classification of Landslides of the Flow Type [*Hungr et al., 2001*], the initial process, composed by phases (1) and (2), may be classified as a flow slide of liquefiable silts and sands. The flow slide is characterized by medium to high mean velocity due to the high pore pressures induced by the previous undrained loading and unloading: this material accumulated at the end of the slope in a tongue-like form at the Stava village (see Fig. 6).

Downstream of the village, during the propagation phases (4) and (5), the mixture, mainly composed by sands and secondarily by silts, was channelled into the Stava valley, and the mass movement turned into an extremely rapid mud/debris flow (see Fig. 6).

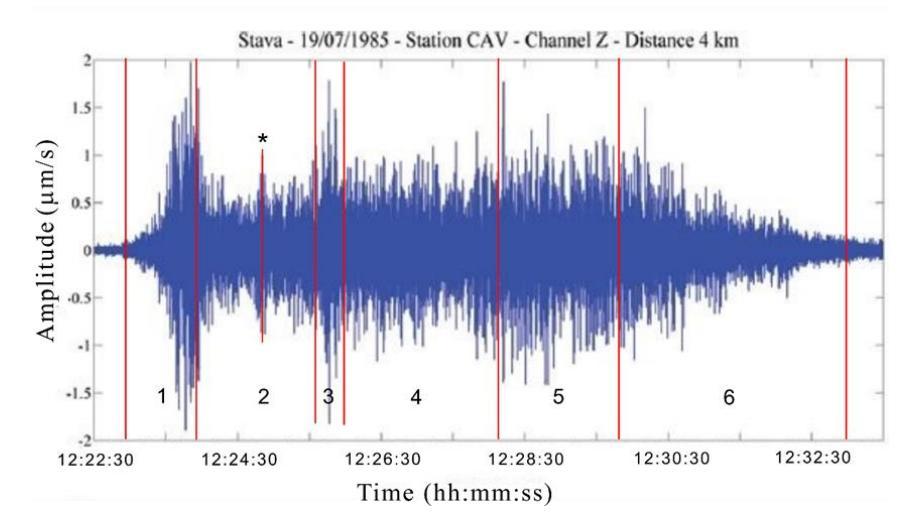
The main phases composing the whole Stava event are visible in the time domain of the induced seismogram (Fig. 7). It lasted approximately 600 s, showing a magnitude between 2 and 3 in the Richter Scale. Amplitudes were rather low, showing peaks mostly lower than 1.5 μ m/s with peak values up to 2 μ m/s.

The phase (1), characterized by increasing amplitudes of the seismic wave, lasts about 60 seconds and corresponds to the upper dams failure and lower dam collapse. In phase (2),

characterized by amplitudes roughly homogeneous for about 100 s, mean velocity is about 6.0 m/s. The peak amplitude registered at 12:24:50 is related to the impact with the buildings closest to the lower dam.

Fig. 7. Seismogram of the Stava event. Numbers are referred to the six distinct phases of the event indicated in Table 3.

In phase (3), lasting about 25 s, the emerging peaks at 12:25:35 correspond to the impact and total wrecking to Stava village; flow velocity increased up to 10.8 m/s. The next phases (4) and (5), characterized by greater amplitude roughly homogeneous, correspond to the propagation of the mass along the Stava valley. In phase (4) mean velocity reached 22.7 m/s for about 130 s until the impact to the Roman bridge of Tesero at 12:28:10; in phase (5), lasting 110 s, the flow reached the Avisio River and mean velocity falls to 4.8 m/s. In phase (6) the amplitudes drop, indicating the deceleration of the mass and eventually the deposition of the material in the Avisio valley.
