# **DEBRIS FLOWS: Disasters, Risk, Forecast, Protection**

Proceedings  
of the 5<sup>th</sup> International Conference

## Reconstruction of debris floods caused by breach of the prehistoric rockslide dams in Central Asia and their parameters assessment

A.L. Strom, A.N. Zhirkevich

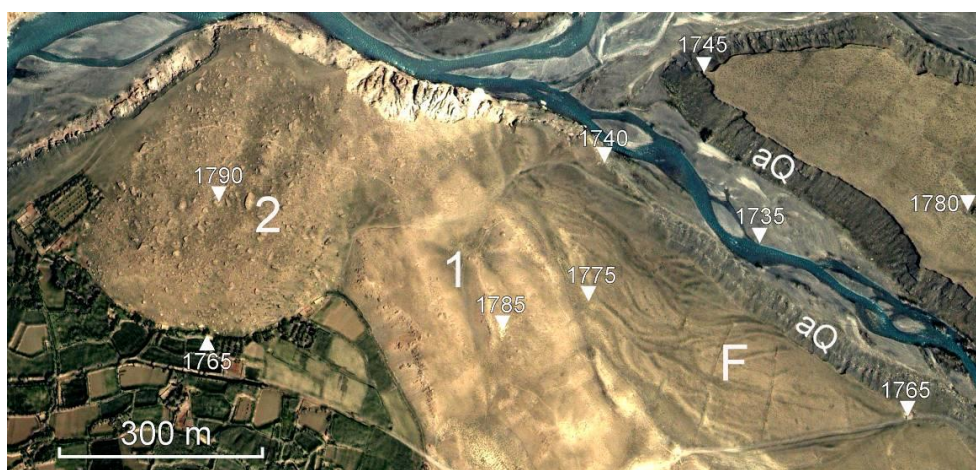
Fig. 3. Possible two generations of the Korgon rock avalanche body and evidence of the outburst flood from upstream. 1 – older generation of debris with smooth surface composed of finer material; 2 – younger generation with much coarser material; F – the specific landforms on the terrace surface left by outburst flood; aQ – fluvial deposits. Google Earth image

Similar features were found in the Sokh River basin in Southern Tien Shan, Kyrgyzstan, just downstream of the confluence of Ak-Terek and the Khodja-Achkan Rivers, where it had been dammed by, likely, two-stage Korgon rock avalanche (Fig. 3).

Peak discharge estimate of the debris flood that formed the dendritic amygdaliform ravines on the 30-40 m high river terrace of the Sokh River downstream from the confluence of the Ak-Terek and the Khodja-Achkan Rivers shown on Fig. 3 is controversial. The most reliable source of this outburst was the breach of the ~150 m high rock avalanche dam about 40 Mm<sup>3</sup> in volume ~4.5 km upstream, in the Ak-Terek River valley. The area of the valley section up to the level slightly exceeding that of the curved terrace is about 8000 m<sup>2</sup>. Considering high velocity of the outburst flood wave, corresponding peak discharge should reach several tens thousands cubic meters per second. However, unlike the Lower Aral and the Aksu outburst floods that had emptied dammed lakes almost completely, the Ak-Terek dammed lake had been silted practically up to the dam's crest level (see Fig. 10). Thus, this rockslide dam breach could not release amount of water large enough to produce so high surge wave.

This discrepancy could be explained if we assume that flood occurred when the Sokh River valley was blocked by the second generation of the Korgon rockslide (marked by '2' on Fig. 3). This dam could fill the river canyon almost up to the terrace level so that outburst flood had entered the inundated valley. Thus, the discharge of the surge wave that curved the amygdaliform ravines could be much lower than if it had to pass through the empty valley. Besides, this wave could trigger the breach of the blockage formed by the second Korgon rockslide.

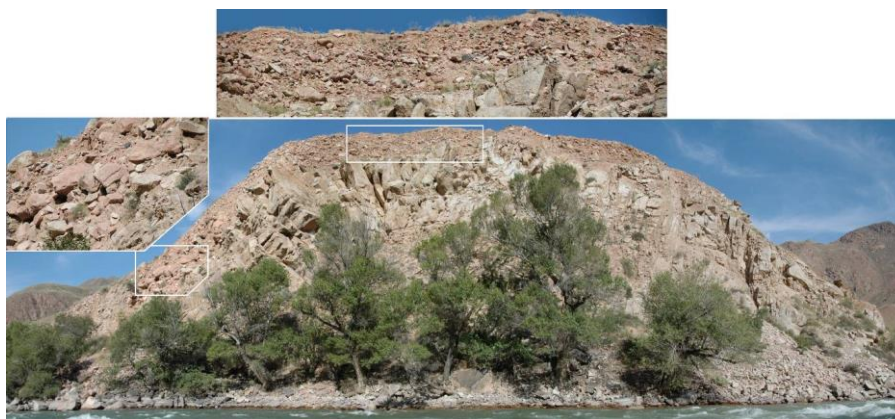
Fig. 8. Debris left by outburst flood after breach of the Lower-Aral rock avalanche dam on the isolated 37 m high cliff. See explanations in the text.

About 2 km downstream of the dam there is a small 37 m high cliff on the right bank of the river covered by an apron of angular granite clasts and with accumulation of large angular boulders of granite up to 1 m in size at its downstream side (Fig. 8). First, most powerful surge wave carrying meter-size boulders eroded from the dams' carapace was so large that it could not pass just through the existing stream and overrode this cliff. Those boulders that passed along the stream were brought far away, but those that pass just above the cliff were deposited in the 'shadow' behind it (see left inset in Fig. 8). The following portions of the outburst debris flow left smaller fragments on top of the cliff with imbricated flattened fragments nearly 40 m above the riverbed level (see upper inset in Fig. 8).

Rough calculations have been performed to estimate peak discharge of the debris flow that left deposits shown on Fig. 8 and 9. Presence of imbricated clasts on top of the ca. 37 m high cliff shows that this flow had passed over it. One-meter size of largest angular boulders carried by this flow and preserved “in the shadow” of this cliff allows estimating flow velocity to be about 10 m/sec at least. Area of the Kokomerren valley section at the level reached by the flood wave was calculated as  $\sim 3000 \text{ m}^2$  that gave peak discharge value of ca.  $30,000 \text{ m}^3/\text{sec}$  (Strom & Zhirkevich, 2013) – almost 50 times more than the maximum value ever recorded here ( $\sim 600 \text{ m}^3/\text{sec}$  according to the State Water Inventory (1987).

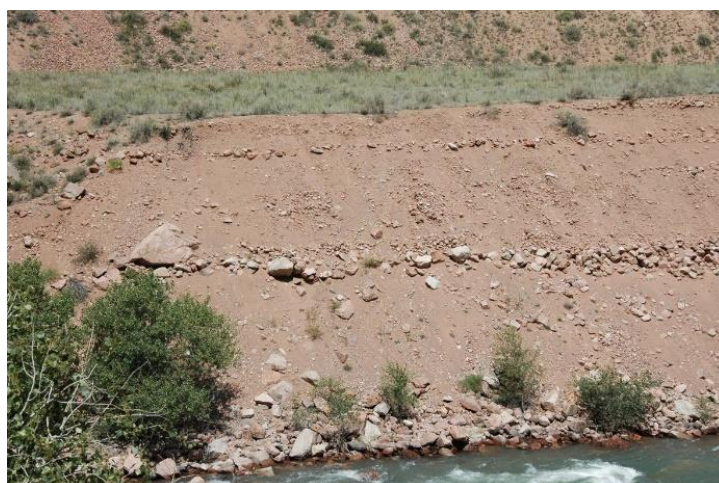
Fig. 9. Typical section of the outburst flood deposits about 14 m thick forming terrace-like surface just downstream of the Lower-Aral breached dam.

Deposits left by the final stages of this catastrophic outburst form the terrace-like surface about 10-14 m above the modern riverbed level on the right bank of the Kokomerren River between two bodies of the Lower-Aral rock avalanche. While morphologically it looks similar to the alluvial river terrace, it is composed of alternating layers of fines and of unrounded angular clasts (Fig. 8). The latter correspond to the episodes of more powerful flow caused by temporal blocking of the erosional canal in the blockage.

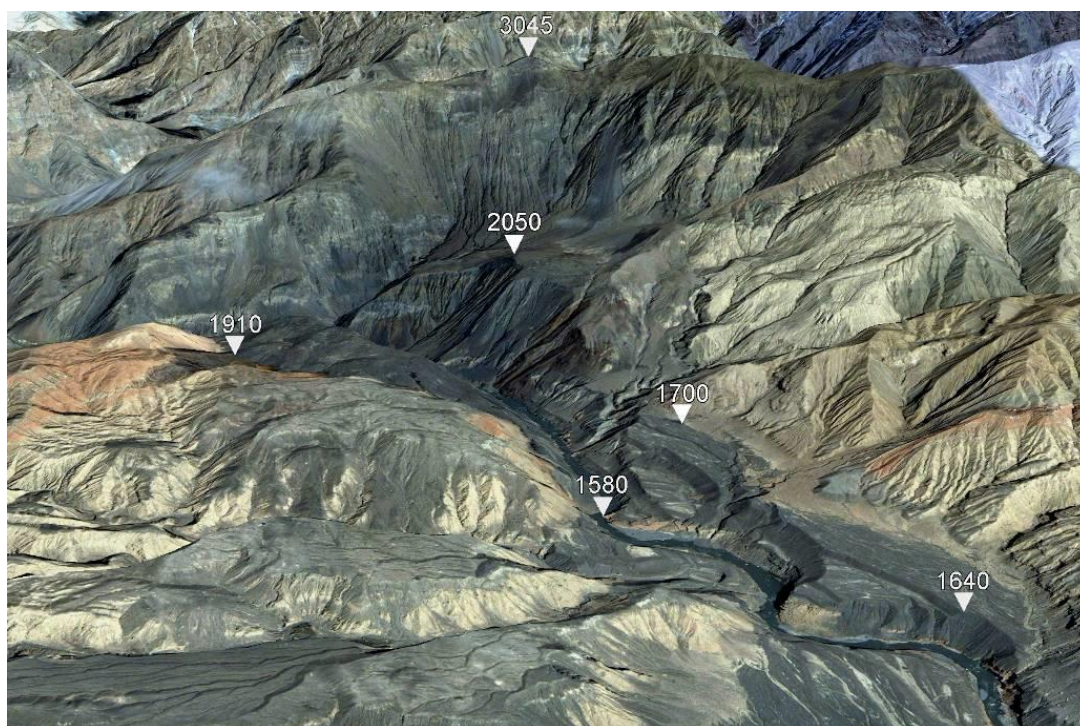
Fig. 11. Evidence of the catastrophic outburst flood caused by the Sarydjaz-Aksu rockslide dam breach – terraces up to 120 m high "painted" by dark-grey debris eroded from the dam's body. 3D Google Earth view

Much more powerful debris flood that curved terraces shown in Fig. 1 and 2 was associated with the breach of the Sarydjaz-Aksu blockage formed by the ca. 300 m high rockslide about 900 Mm<sup>3</sup> in volume at 41.764° N, 79.526° E. The 31 km long dammed lake could store up to 2.2 – 2.5 km<sup>3</sup> of water. This slope failure occurred on a slope composed of the dark grey Carboniferous metasediments, while area downstream is composed of pink and reddish Paleozoic and Cenozoic sedimentary rocks (Fig. 11).

Immediately downstream from the dam the surge wave had painted river terraces by black debris eroded from the dam's body up to 120 m above the riverbed and ~700 m wide. About 2 km downstream outburst flood wave became wider – nearly up to 1000 m and affected river banks up to 80 m high. Considering generally triangular cross-section of the river valley and ~10 m<sup>3</sup>/sec velocity of the outburst flow (in fact it could be even higher), the peak discharge could reach 400,000 – 500,000 m<sup>3</sup>/sec – about 4 times more than that of the 2000 Yigong outburst flood [Wang, 2008; Xu *et al.*, 2008; Evans, Delaney, 2011]. The dam was breached almost completely and do not form any distinct knickpoint.
