СЕЛЕВЫЕ ПОТОКИ: катастрофы, риск, прогноз, защита

Труды
8-й Международной конференции

The safety of city Telavi from the destructive effects of debris flow

G.V. Gavardashvili

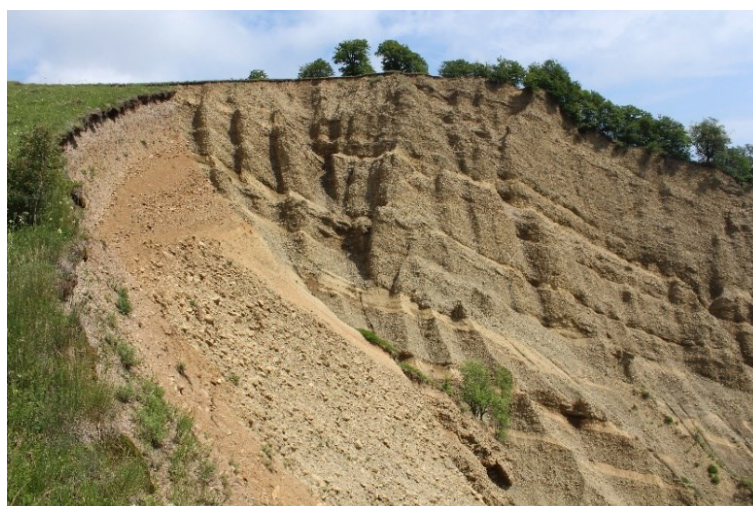
Fig. 3. General view of the erosive gully of the Telaviskhevi River

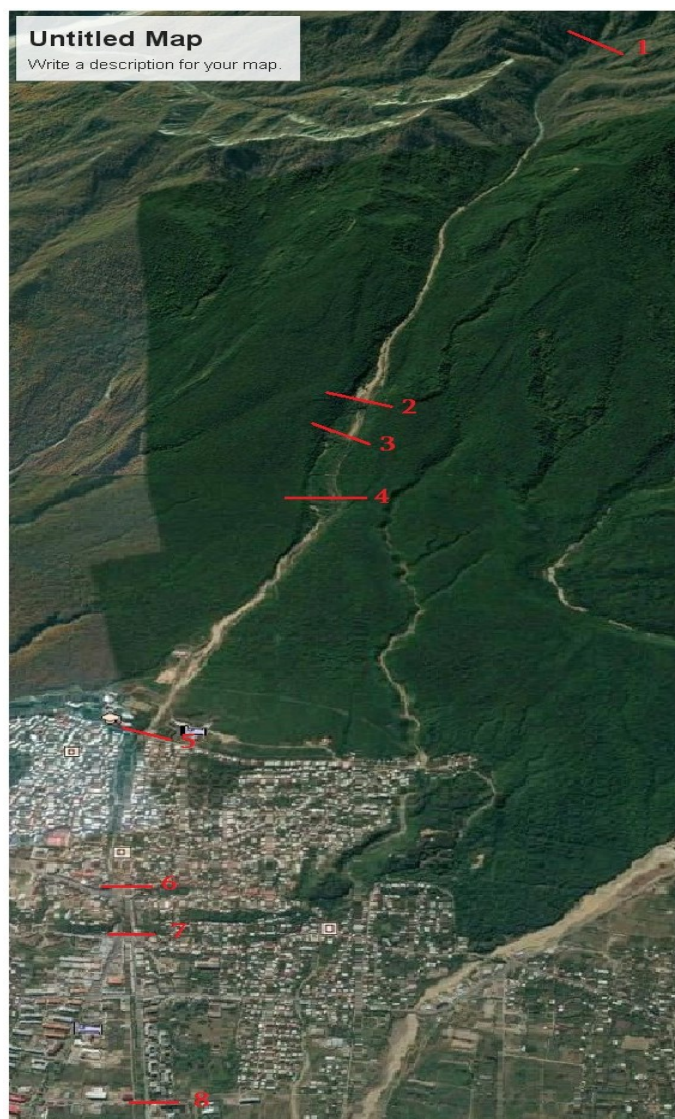
The number of design cross-sections to determine the flooded area from the land boundary in the tailrace direction should not exceed 8 (Fig. 3), the distance between which should be marked in advance on the digital topographic map.

Fig. 3. Design sections recorded in the Telaviskhevi River bed
